# Peace Of Mind Home Inspections

123 Sample Street  
Quiet Town, MN

Prepared for: **Mr and Mrs Happy Buyers**

Prepared by: **Peace of Mind Home Inspections**

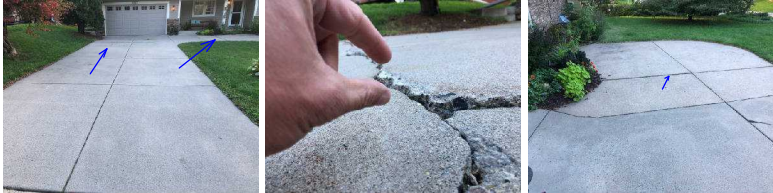
1. Marginal Driveway: Concrete - Cracks noted. Recommend filling cracks in driveway as regular maintenance every 2- 4 years, Trip Hazard. Uneven areas may be a trip hazard. recommend grinding down top edge and caulking gaps then monitoring.

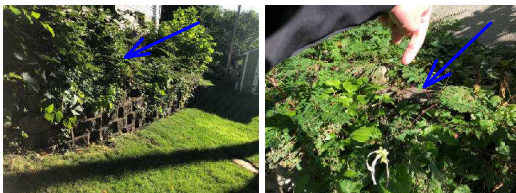
5. Marginal Retaining Walls: Block - Smaller wall on side of home leaning on side of home. Recommend correction.

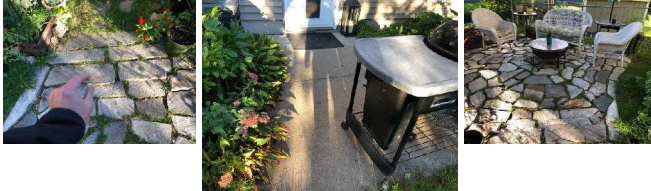
9. Marginal Patio: Concrete and paver. - Uneven pads/ pavers. Recommend leveling to avoid trip hazards.

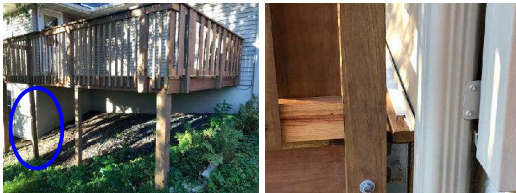
10. Marginal Deck: Wood - Footings /posts below ground or rocks not fully observed. Assumed proper depth. Post is canted. Recommend monitoring. No flashing was observed above the ledger board. Flashing helps keep water from getting behind the ledger board and getting along the home exterior material. There is a flashing across the top of the first row of decking which will provide a similar function

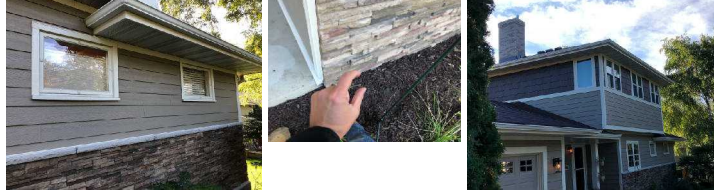
1. Acceptable, Not Inspected Type: Stone and Vinyl - Recommend removing mulch at the base of the front stone to ensure there is a 4 inch gap between any grading and the stonework for proper drainage.

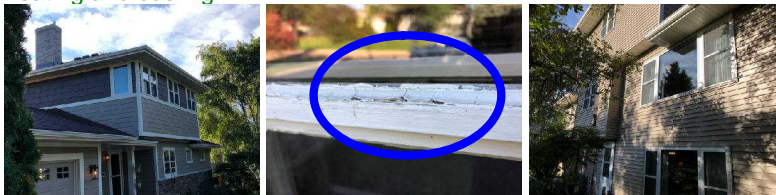
8. Marginal Windows: double hung - Loose or damaged glazing. Some of the windows have glazing that is starting to fail that should be redone as the glazing is what holds the window pane in place and keeps up the efficiency of the heating and cooling.

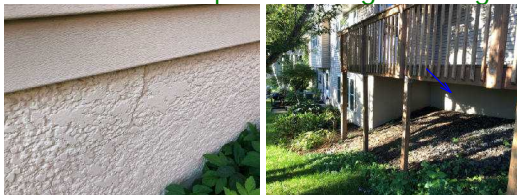
18. Acceptable, Not Inspected Exterior Venting Not all vents could be closely observed due to brush and slope on right side of home. Recommend trimming back bushes and checking vents at least once a year.

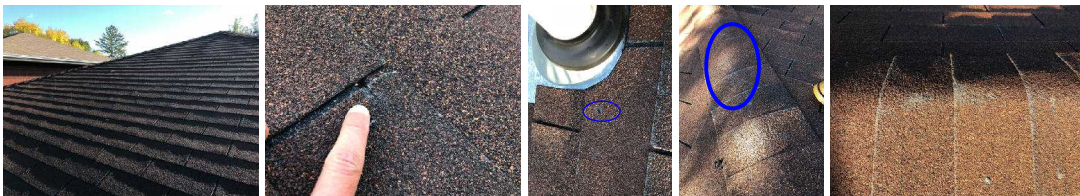
1. Method of Inspection: On roof
2. Not Inspected Unable to Inspect: 25%
3. Marginal Material: Asphalt shingle - Significant granular loss. Some of the areas appear to have been scraped by a roof rake. Its recommended to get a roof rake that has rollers on the bottom. This may indicate that roof raking is recommended to reduce chances of ice damming. The granular loss and scratched areas will shorten life of the roof. Recommend qualified contractor evaluate the roof and seal all holes and tears. Exposed nail heads. There are some nail heads in the shingles that are exposed. These nail heads should be caulked or sealed to prevent any possible moisture intrusion into the roofing material. Lifted shingles in rear near gutters. There are couple of shingles that appear to be lifting up in center or edges. These should be properly secured and flush with the surrounding shingles to avoid being wind blown and torn. Roof past half of its estimated useful life

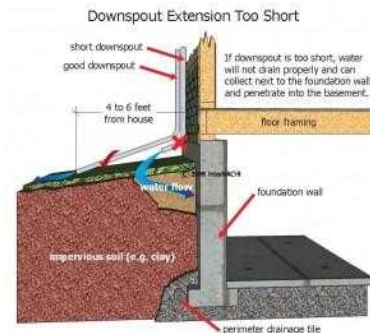
13. Marginal Leader/Extension: Shorter than recommended - Some not attached. Extensions should always terminate 6-8 feet from the home in a direction that takes water downhill away from home.

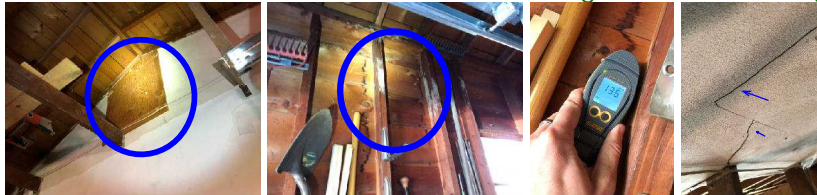
7. Not Inspected, Marginal Wall Exposed framing - Missing fire rated drywall over the house attic access. Recommend patching cracks near attic and monitoring. All drywall that is part of the fire barrier should have any gaps or holes patched to maintain a proper fire barrier. Due to the amount of personal items or shelving along the walls the inspector was not able to get a good look at all the wall material. Acceptable moisture levels observed on stained areas. Evidence of past water staining that tested within acceptable levels when measured. Recommend further investigation / monitoring.

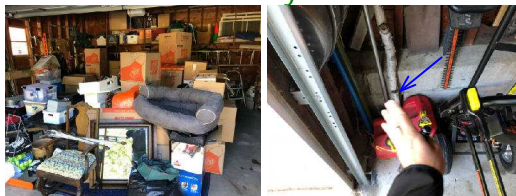
9. Not Inspected, Marginal Floor/Foundation: Poured slab - Recommend patching gaps in mortar on far side of garage and monitoring. Floor cracks and pitting spots are noted. It is recommended to seal the cracks and pitting to prevent further deterioration. No signs of significant separation or displacement observed unless otherwise stated. Due to the amount of personal belongings covering the floor the inspector was not able to get a good look at the entire floor for any indications of further cracking or problems.

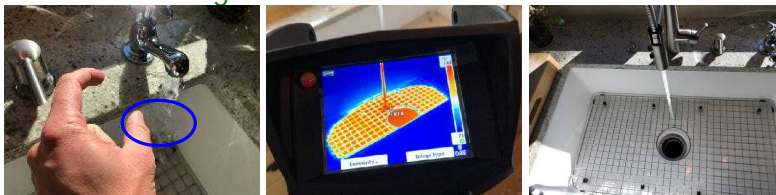
Sink: Stainless Steel - The small faucet is too short and is putting water on to the countertop. Recommend longer faucet head.

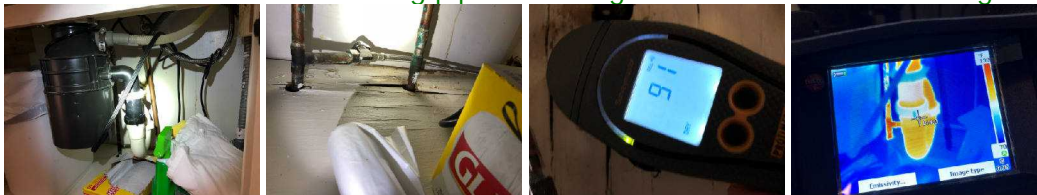
10. Marginal

Plumbing/Fixtures: PVC - Signs of past leaking. Acceptable levels were noted where tested under sink. recommend cleaning pipes checking connections and monitoring

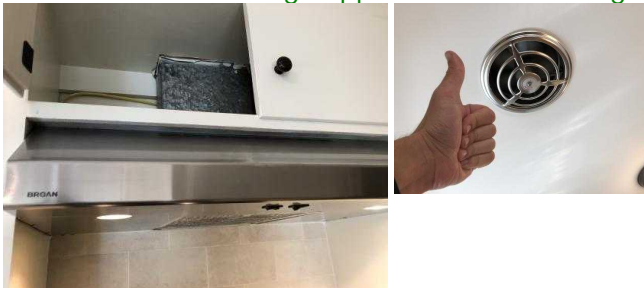
15. Acceptable Ventilator: Functional - Older unit may not vent outside anymore after 2nd story addition. The new unit over the range appeared to be venting outside

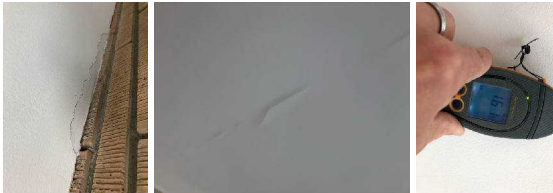
2. Marginal

Ceiling: Texture paint - There are cracks in the paint of the ceiling. No signs of significant separation or displacement of the ceiling material were observed. The cracks may be due expansion and contraction. recommend filling with paintable caulking monitoring. Tested consistent with unaffected areas.

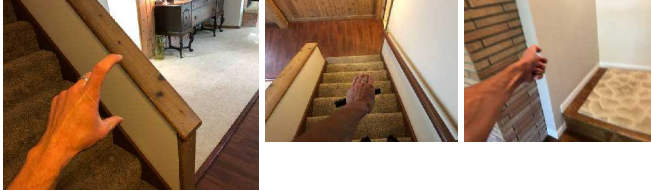
9. Marginal Stair Handrail and Steps recommend handrail in short steps to landing. Recommend handrails return on ends to avoid people catching items on the railing. basement. guardrails to low to basement Recommend handrails be 34 to 36 inches high.

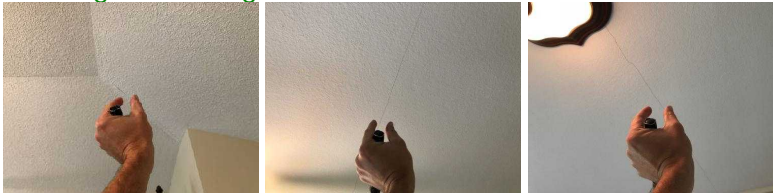
2. Marginal

Ceiling: Texture paint - There are cracks in the paint of the ceiling. No signs of significant separation or displacement of the ceiling material were observed. The cracks may be due expansion and contraction or settlement of the addition. recommend filling with paintable caulking monitoring

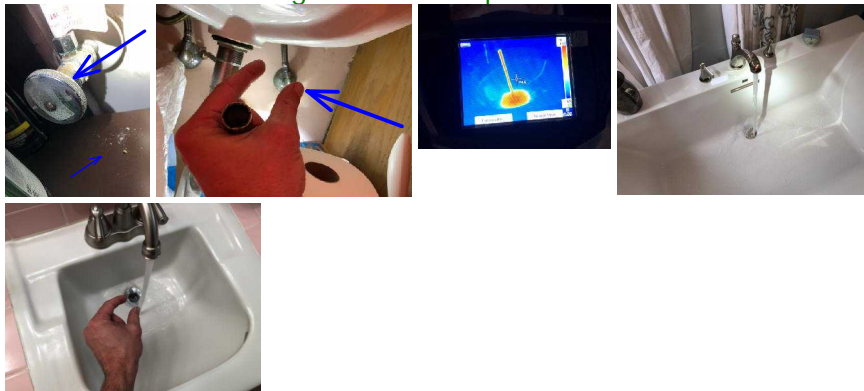
- 8. Not Inspected, Marginal Sink/Basin: Porcelain coated - No shut offs observed at the main level bathroom sink plumbing. Missing stopper. Corrosion noted on the lower level bathroom sink plumbing recommend monitoring. Valves not operated.

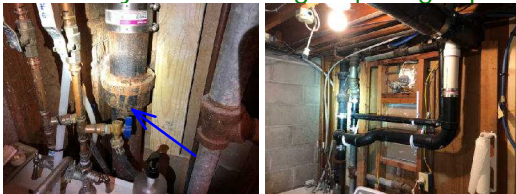
4. Marginal Drain Pipes: ABS, Cast iron and Galvanized - Staining noted at wax ring near the washing machine. Recommend repairing wax ring and monitoring. Inspectors cannot determine the condition of the pipe from the home to the street. If you are concerned about this, you should consider having a plumber run a camera through the lines to establish its condition. Sewer / Water Line insurance is available at a very low cost and is a good idea. Galvanized drainpipe present. galvanized and cast iron drain pipes are known for building up material on the inside or eventually deteriorating requiring replacement.

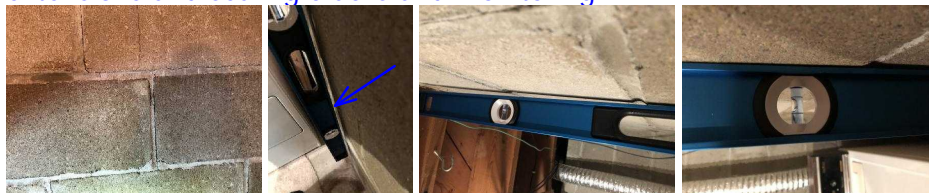
3. Not Inspected, Marginal Differential Movement: Potential bowing and stair step cracks. Mostly Covered. there were stairstep cracks and some minor in word deflection or bowing on the wall facing the front of the house in the laundry room. This is typically a sign of wet ground freezing and the frozen ground pushing on the wall. The bowing is in early stages. Recommend cleaning the gutters improving the grading extending the gutter extensions and sealing cracks and monitoring.
