# Peace Of Mind Home Inspections

123 Sample Street  
Quiet Town, MN

Prepared for: **Mr and Mrs Happy Buyers**

Prepared by: **Peace of Mind Home Inspections**

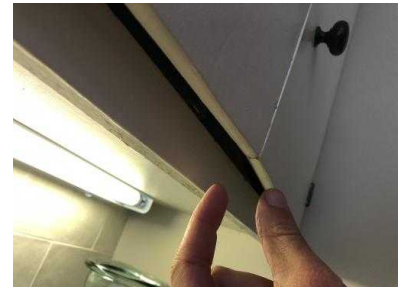
6. Marginal Cabinets: Wood - Some cabinet doors were not fully closing and may need to be sanded or adjusted

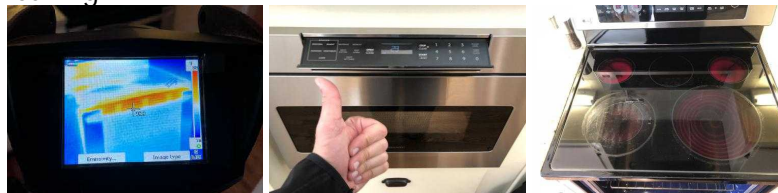
14. Acceptable, Not Inspected Cooking Appliances: Functional - The cooking appliances were tested. Ovens are warmed but not brought up to full temp to avoid any ovens being left on while outside the room. This reduces chances of anything being accidentally left on after leaving.

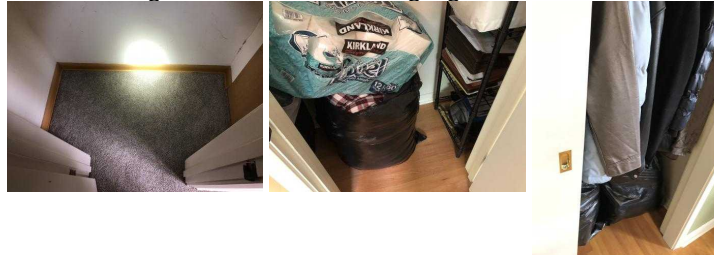
Doors: Wood - The LL door is sticking, Doors need trimming/adjustment. Damaged frame.

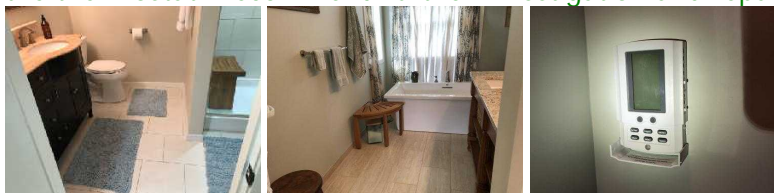
1. Not Inspected, Marginal Floor: Tile - **The in floor heat in master bathroom was not responsive after operating the thermostat. Recommend further investigation and repair if needed.**

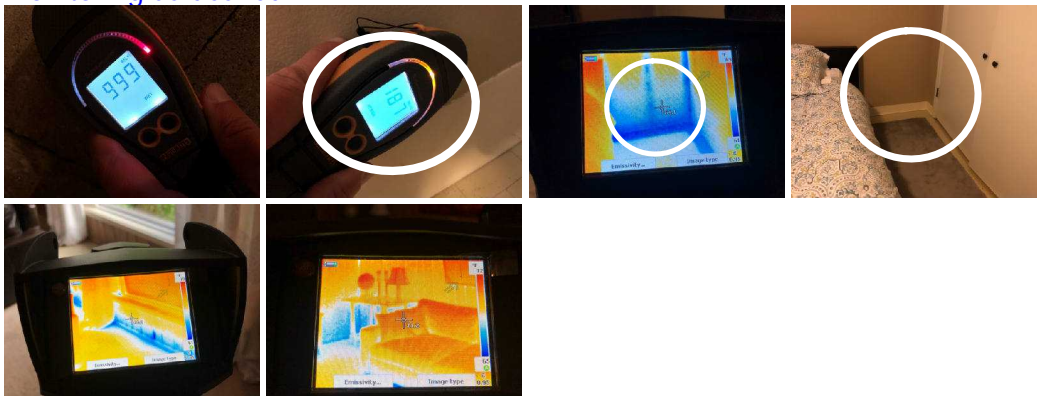
10. Marginal Moisture Location: Near laundry room and on bedroom side of the level - Elevated moisture levels noted in the laundry room. These levels reached the maximum measurable amount of the moisture meter (99.9%) however no active water entry was observed. There was also some at risk moisture level readings in the lower bedroom between the bed and the closet. These areas may require exterior grading improvements, cleaning the gutters above and adding exterior gutter extensions that are longer. It would be recommended to fill and seal any gaps and Paint the concrete walls with water resistant paint. As a final option drain tile and sump pump will also help run the water out of the area surrounding the basement. The inspector tested multiple walls in the lower level. The areas with the wood paneling tested within acceptable levels. The infrared camera showed some cooler signatures which may be indicative of drafting or evaporation from possibly damp concrete blocks. Recommend further investigation or monitoring as desired

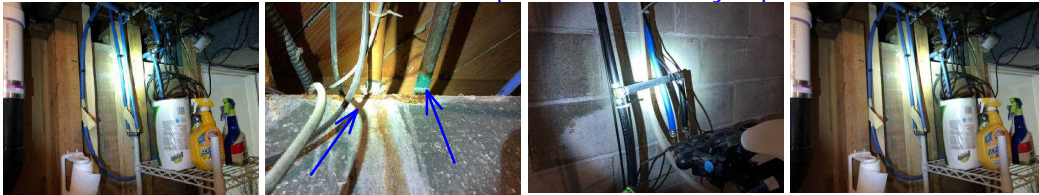
3. Marginal Water Lines: Copper and PEX - Corroded pipes showed signs of past leaking above the furnace. Recommend further evaluation and repair as needed by a plumber

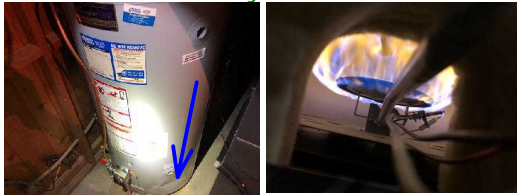
9. Marginal Water Heater Operation: Functional at time of inspection - Unit dented. Manufacturers recommend (on new units) draining water heater annually to flush debris in the tank. Use caution and follow manufacturers instructions. Manufacturers estimate life of most units to be between 7 and 12 years.

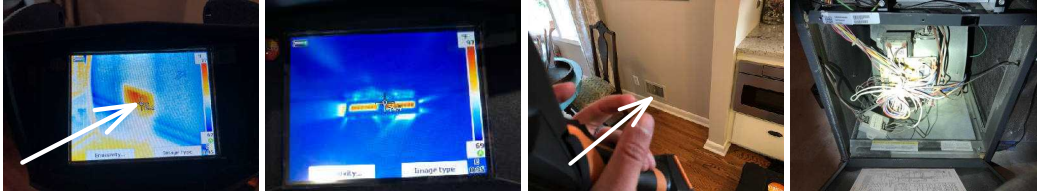
8. Marginal Distribution: Metal duct - limited air flow in dining area near kitchen. recommend checking dampers and further investigation.

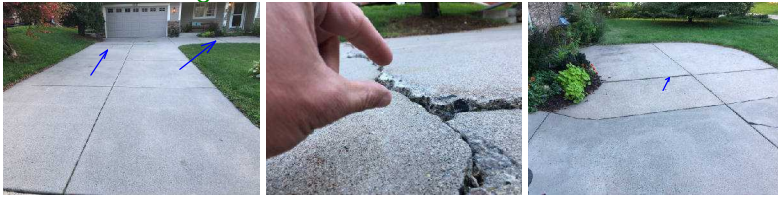
1. Marginal Driveway: Concrete - Cracks noted. Recommend filling cracks in driveway as regular maintenance every 2- 4 years, Trip Hazard. Uneven areas may be a trip hazard. recommend grinding down top edge and caulking gaps then monitoring.

1. Driveway: Concrete - Cracks noted. Recommend filling cracks in driveway as regular maintenance every 2- 4 years, Trip Hazard. Uneven areas may be a trip hazard. recommend grinding down top edge and caulking gaps then monitoring.

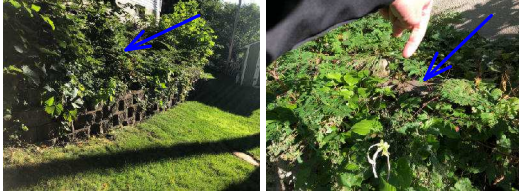
5. Marginal Retaining Walls: Block - Smaller wall on side of home leaning on side of home. Recommend correction.

3. Retaining Walls: Block - Smaller wall on side of home leaning on side of home. Recommend correction.

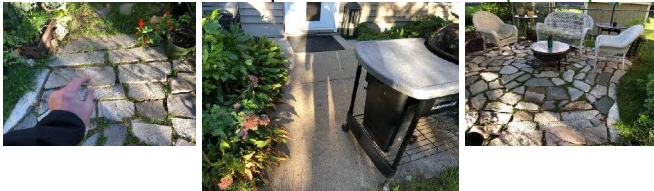
9. Marginal Patio: Concrete and paver. - Uneven pads/ pavers. Recommend leveling to avoid trip hazards.

5. Patio: Concrete and paver. - Uneven pads/ pavers. Recommend leveling to avoid trip hazards.

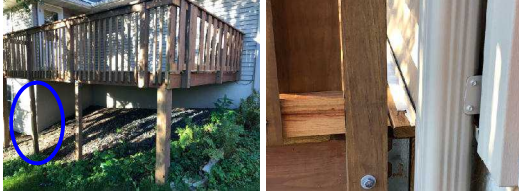
10. Marginal Deck: Wood - Footings /posts below ground or rocks not fully observed. Assumed proper depth. Post is canted. Recommend monitoring. No flashing was observed above the ledger board. Flashing helps keep water from getting behind the ledger board and getting along the home exterior material. There is a flashing across the top of the first row of decking which will provide a similar function

6. Deck: Wood - Footings /posts below ground or rocks not fully observed. Assumed proper depth. Post is canted. Recommend monitoring. No flashing was observed above the ledger board. Flashing helps keep water from getting behind the ledger board and getting along the home exterior material. There is a flashing across the top of the first row of decking which will provide a similar function

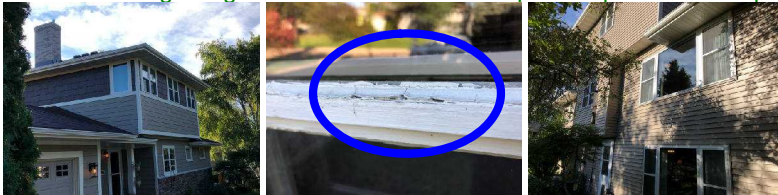
8. Marginal Windows: double hung - Loose or damaged glazing. Some of the windows have glazing that is starting to fail that should be redone as the glazing is what holds the window pane in place and keeps up the efficiency of the heating and cooling.

8. Windows: double hung - Loose or damaged glazing. Some of the windows have glazing that is starting to fail that should be redone as the glazing is what holds the window pane in place and keeps up the efficiency of the heating and cooling.

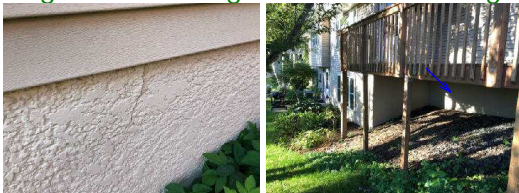
16. Acceptable      Gas Meter: Exterior surface mount at side of home
17. Marginal      Exterior Foundation Cracks. No significant displacement observed. Recommend patching and monitoring cracks and gaps in skim coat over foundation. Cracks are typically a result of moisture build up then rising as the ground heaving as it freezes or original settlement.

12. Exterior Foundation Cracks. No significant displacement observed. Recommend patching and monitoring cracks and gaps in skim coat over foundation. Cracks are typically a result of moisture build up then rising as the ground heaving as it freezes or original settlement.

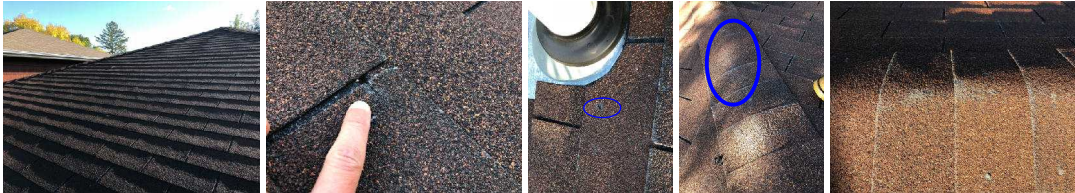
1. Method of Inspection: On roof
2. Not Inspected Unable to Inspect: 25%
3. Marginal Material: Asphalt shingle - Significant granular loss. Some of the areas appear to have been scraped by a roof rake. Its recommended to get a roof rake that has rollers on the bottom. This may indicate that roof raking is recommended to reduce chances of ice damming. The granular loss and scratched areas will shorten life of the roof. Recommend qualified contractor evaluate the roof and seal all holes and tears. Exposed nail heads. There are some nail heads in the shingles that are exposed. These nail heads should be caulked or sealed to prevent any possible moisture intrusion into the roofing material. Lifted shingles in rear near gutters. There are couple of shingles that appear to be lifting up in center or edges. These should be properly secured and flush with the surrounding shingles to avoid being wind blown and torn. Roof past half of its estimated useful life

13. Main Roof Surface Material: Asphalt shingle - Significant granular loss. Some of the areas appear to have been scraped by a roof rake. It's recommended to get a roof rake that has rollers on the bottom. This may indicate that roof raking is recommended to reduce chances of ice damming. The granular loss and scratched areas will shorten life of the roof. Recommend qualified contractor evaluate the roof and seal all holes and tears. Exposed nail heads. There are some nail heads in the shingles that are exposed. These nail heads should be caulked or sealed to prevent any possible moisture intrusion into the roofing material. Lifted shingles in rear near gutters. There are couple of shingles that appear to be lifting up in center or edges. These should be properly secured and flush with the surrounding shingles to avoid being wind blown and torn. Roof past half of its estimated useful life

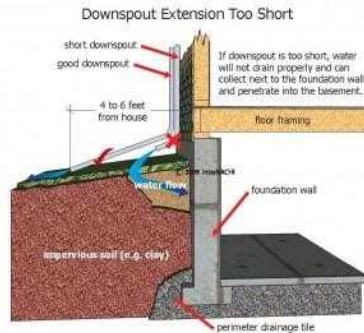
13. Marginal Leader/Extension: Shorter than recommended - Some not attached. Extensions should always terminate 6-8 feet from the home in a direction that takes water downhill away from home.

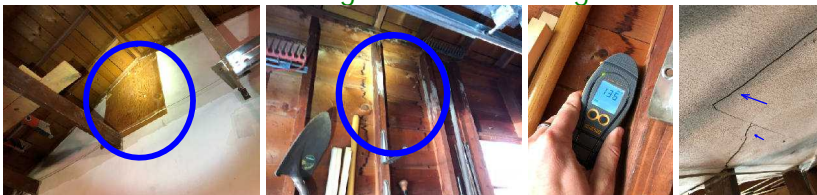
18. Attached Garage Wall Exposed framing - Missing fire rated drywall over the house attic access. Recommend patching cracks near attic and monitoring. All drywall that is part of the fire barrier should have any gaps or holes patched to maintain a proper fire barrier. Due to the amount of personal items or shelving along the walls the inspector was not able to get a good look at all the wall material. Acceptable moisture levels observed on stained areas. Evidence of past water staining that tested within acceptable levels when measured. Recommend further investigation / monitoring.

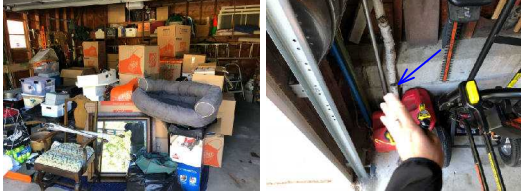
20. Attached Garage Floor/Foundation: Poured slab - Recommend patching gaps in mortar on far side of garage and monitoring. Floor cracks and pitting spots are noted. It is recommended to seal the cracks and pitting to prevent further deterioration. No signs of significant separation or displacement observed unless otherwise stated. Due to the amount of personal belongings covering the floor the inspector was not able to get a good look at the entire floor for any indications of further cracking or problems.

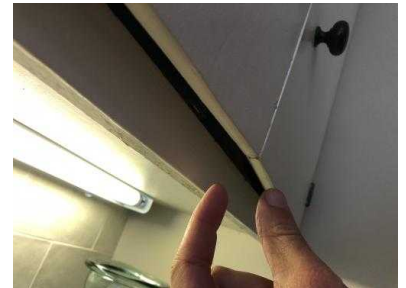
23. 1st Floor Kitchen Cabinets: Wood - Some cabinet doors were not fully closing and may need to be sanded or adjusted

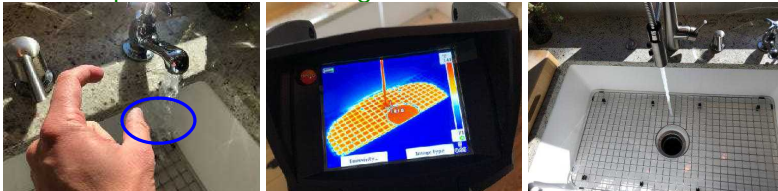
25. 1st Floor Kitchen Sink: Stainless Steel - The small faucet is too short and is putting water on to the countertop. Recommend longer faucet head.

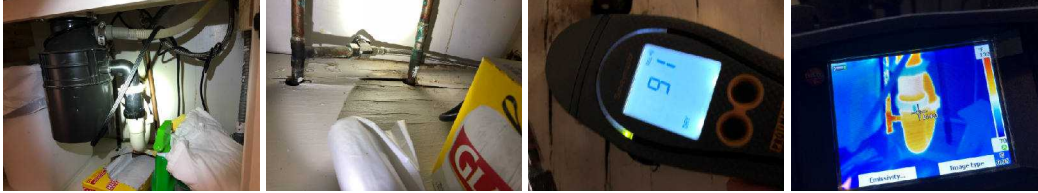
26. 1st Floor Kitchen Plumbing/Fixtures: PVC - Signs of past leaking. Acceptable levels were noted where tested under sink. recommend cleaning pipes checking connections and monitoring

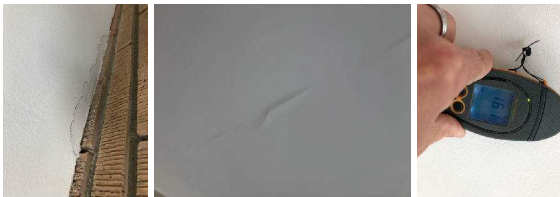
28. All Living Area's Living Space Ceiling: Texture paint - There are cracks in the paint of the ceiling. No signs of significant separation or displacement of the ceiling material were observed. The cracks may be due expansion and contraction. recommend filling with paintable caulking monitoring. Tested consistent with unaffected areas.

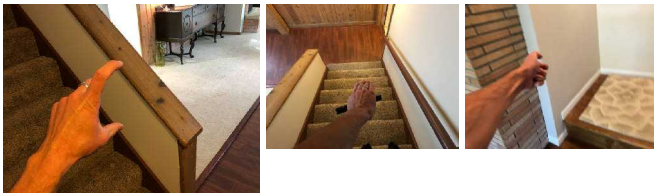
31. All Living Area's Living Space Stair Handrail and Steps recommend handrail in short steps to landing. Recommend handrails return on ends to avoid people catching items on the railing. basement. guardrails to low to basement Recommend handrails be 34 to 36 inches high.

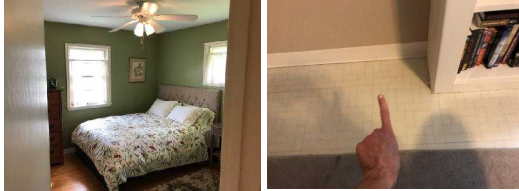
38. All Bedroom Floor: Wood, Tile and Carpet - Hole drilled in wood floor. Main level. Possible asbestos tiles (LL) recommend checking out the EPA's website at [www.epa.gov](http://www.epa.gov)

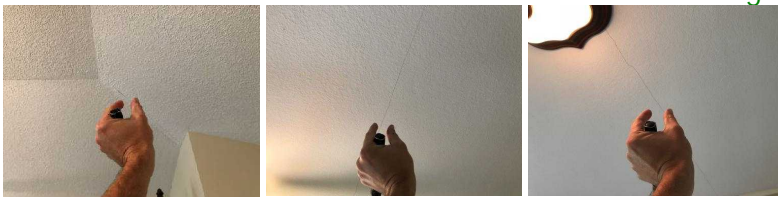
39. All Bedroom Ceiling: Texture paint - There are cracks in the paint of the ceiling. No signs of significant separation or displacement of the ceiling material were observed. The cracks may be due expansion and contraction or settlement of the addition. recommend filling with paintable caulking monitoring

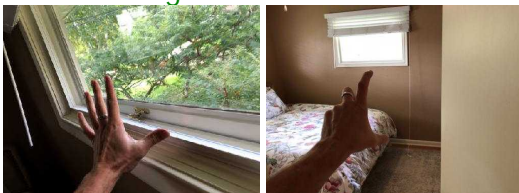
42. All Bedroom Windows: Vinyl Double Hung and Casement - Some of the windows have a separate piece of glass inserted between the controls and the window. Which prevented the inspector from reaching the controls and testing these windows. The windows on the main level or higher from the ground than standard egress windows. And may be difficult for someone to exit during an emergency. Recommend building temporary stairs especially if children are going to be in the room. Modern safety guidelines recommend windows be within 44 inches of the ground.

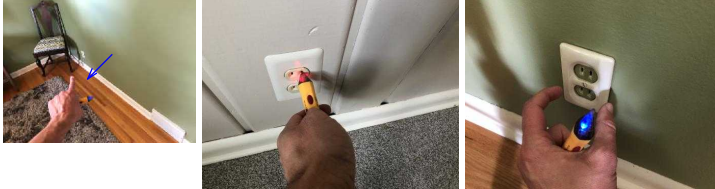
43. All Bedroom Electrical: 110 VAC - Reversed polarity noted in green bedroom on 2 prong outlet. There are some non grounded or 2 prong receptacles. If possible it is recommended to replace the 2 prong receptacles with the proper grounded three-prong receptacles.

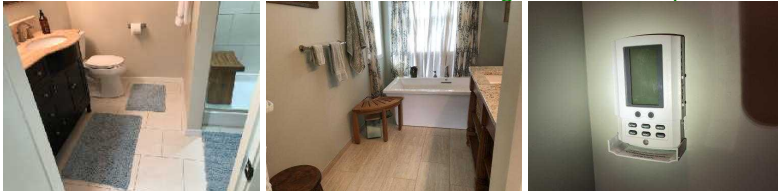
45. All Bathroom Floor: Tile - The in floor heat in master bathroom was not responsive after operating the thermostat. Recommend further investigation and repair if needed.

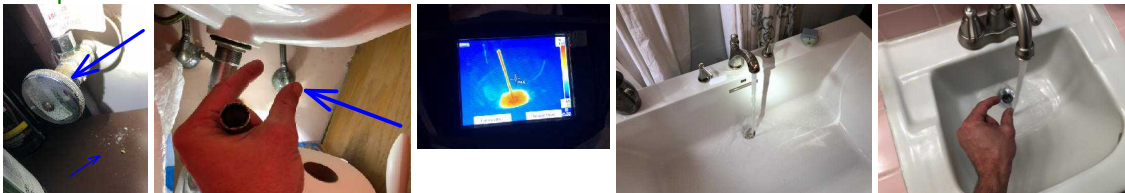
47. All Bathroom Sink/Basin: Porcelain coated - No shut offs observed at the main level bathroom sink plumbing. Missing stopper. Corrosion noted on the lower level bathroom sink plumbing recommend monitoring. Valves not operated.

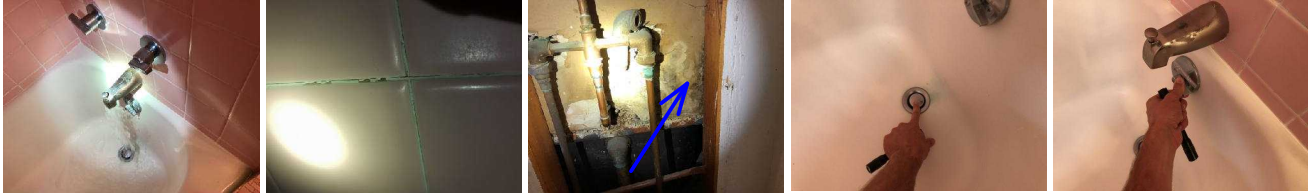
48. All Bathroom Tub/Surround: Porcelain tub and ceramic tile surround - ( Main Level ) Loose grout between the tiles in the surround, Recommend repair to avoid any more water from getting behind wall. Moisture behind the wall can cause damage or growth. Recommend further investigation or repair. stopper not working. Recommend caulking faucet head and control covers on top and sides to reduce chances of water damage. Staining in potential growth noted on the backside of the shower. This may have been from previous water damage. Recommend further investigation and repair as needed. No active leak observed at the time of inspection.

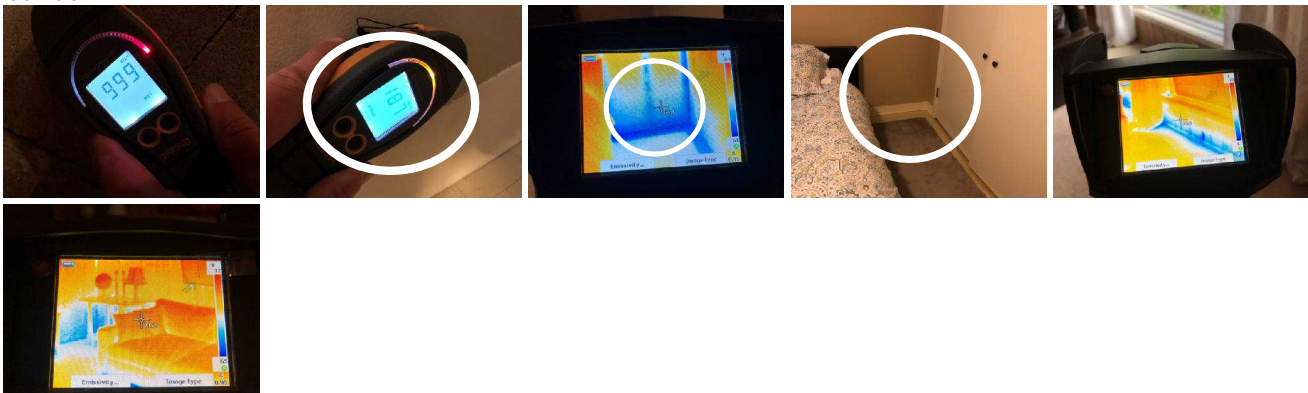
50. Main (Unfinished Areas) Basement Moisture Location: Near laundry room and on bedroom side of the level - Elevated moisture levels noted in the laundry room. These levels reached the maximum measurable amount of the moisture meter (99.9%) however no active water entry was observed. There was also some at risk moisture level readings in the lower bedroom between the bed and the closet. These areas may require exterior grading improvements, cleaning the gutters above and adding exterior gutter extensions that are longer. It would be recommended to fill and seal any gaps and Paint the concrete walls with water resistant paint. As a final option drain tile and sump pump will also help run the water out of the area surrounding the basement. The inspector tested multiple walls in the lower level. The areas with the wood paneling tested within acceptable levels. The infrared camera showed some cooler signatures which may be indicative of drafting or evaporation from possibly damp concrete blocks. Recommend further investigation or monitoring as desired

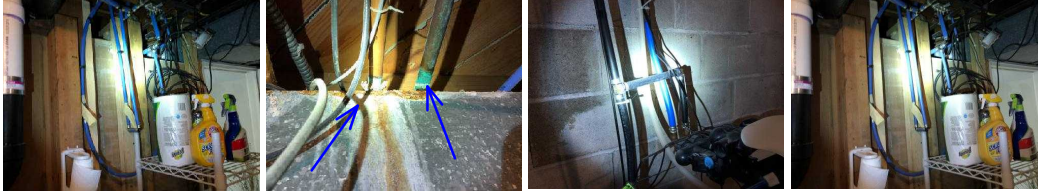
51. Water Lines: Copper and PEX - Corroded pipes showed signs of past leaking above the furnace. Recommend further evaluation and repair as needed by a plumber

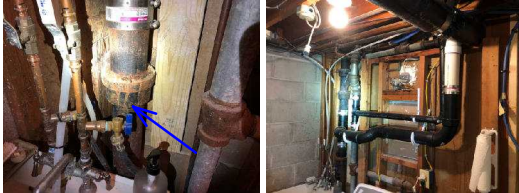
52. Drain Pipes: ABS, Cast iron and Galvanized - Staining noted at wax ring near the washing machine. Recommend repairing wax ring and monitoring. Inspectors cannot determine the condition of the pipe from the home to the street. If you are concerned about this, you should consider having a plumber run a camera through the lines to establish its condition. Sewer / Water Line insurance is available at a very low cost and is a good idea. Galvanized drainpipe present. galvanized and cast iron drain pipes are known for building up material on the inside or eventually deteriorating requiring replacement.

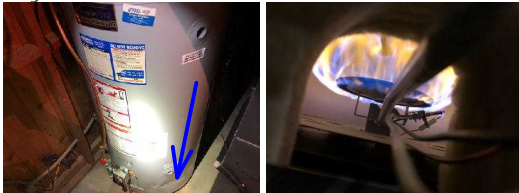
53. Basement Water Heater Water Heater Operation: Functional at time of inspection - Unit dented. Manufacturers recommend (on new units) draining water heater annually to flush debris in the tank. Use caution and follow manufacturers instructions. Manufacturers estimate life of most units to be between 7 and 12 years.

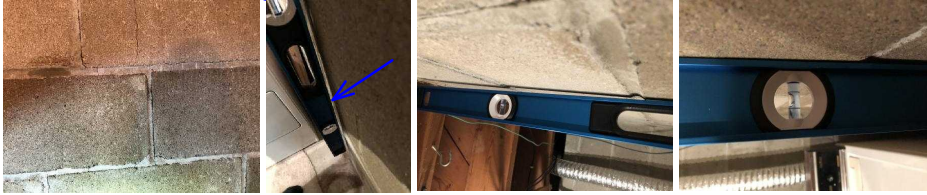
56. Differential Movement: Potential bowing and stair step cracks. Mostly Covered. there were stairstep cracks and some minor in word deflection or bowing on the wall facing the front of the house in the laundry room. This is typically a sign of wet ground freezing and the frozen ground pushing on the wall. The bowing is in early stages. Recommend cleaning the gutters improving the grading extending the gutter extensions and sealing

Differential Movement: (continued)  
cracks and monitoring.

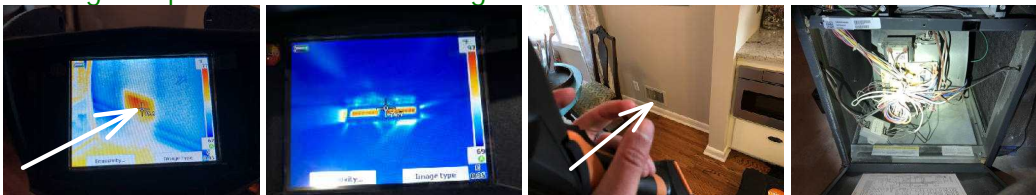
59. Main Heating System Distribution: Metal duct - limited air flow in dining area near kitchen. recommend checking dampers and further investigation.
